## An Analysis of Bicycle-Vehicle Interactions at Signalized Intersections with Bicycle Boxes

William Robert Farley  
*Portland State University*

Master of Science  
in  
Civil and Environmental Engineering

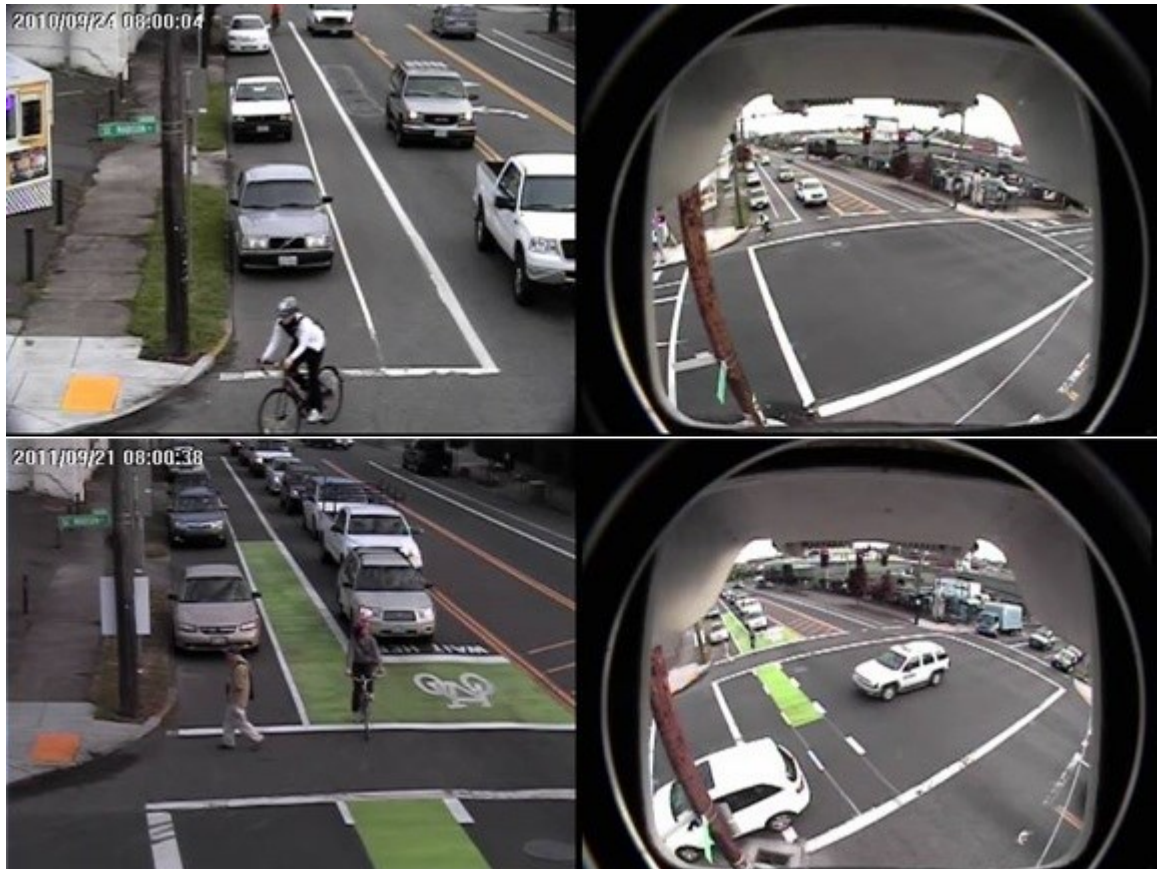
The intersection of SE 7<sup>th</sup> Avenue at Madison Street was also observed at similar periods before and after the installation of the advanced stop box about a year apart. This intersection is two blocks north of the study intersection of SE 7<sup>th</sup> Avenue at Hawthorne Boulevard. The bike box was installed on the southbound SE 7<sup>th</sup> Avenue approach. Much like the intersection at Hawthorne Boulevard, SE 7<sup>th</sup> Avenue is a three-lane, two-way roadway with a center two-way left-turn lane. Bike lanes and on-street parking areas are available on both sides of the street on both sides of the intersection. It was observed in the videos that majority of the bicyclists were turning right to use Madison to cross the Hawthorne Bridge. Since Madison Street is a one-way street traveling westbound, the southbound left-turn from SE 7<sup>th</sup> Avenue is restricted. Figure 8 shows the available camera views at the intersection for both study periods.

**Figure 8: SE 7th Ave at Madison St Camera Views**

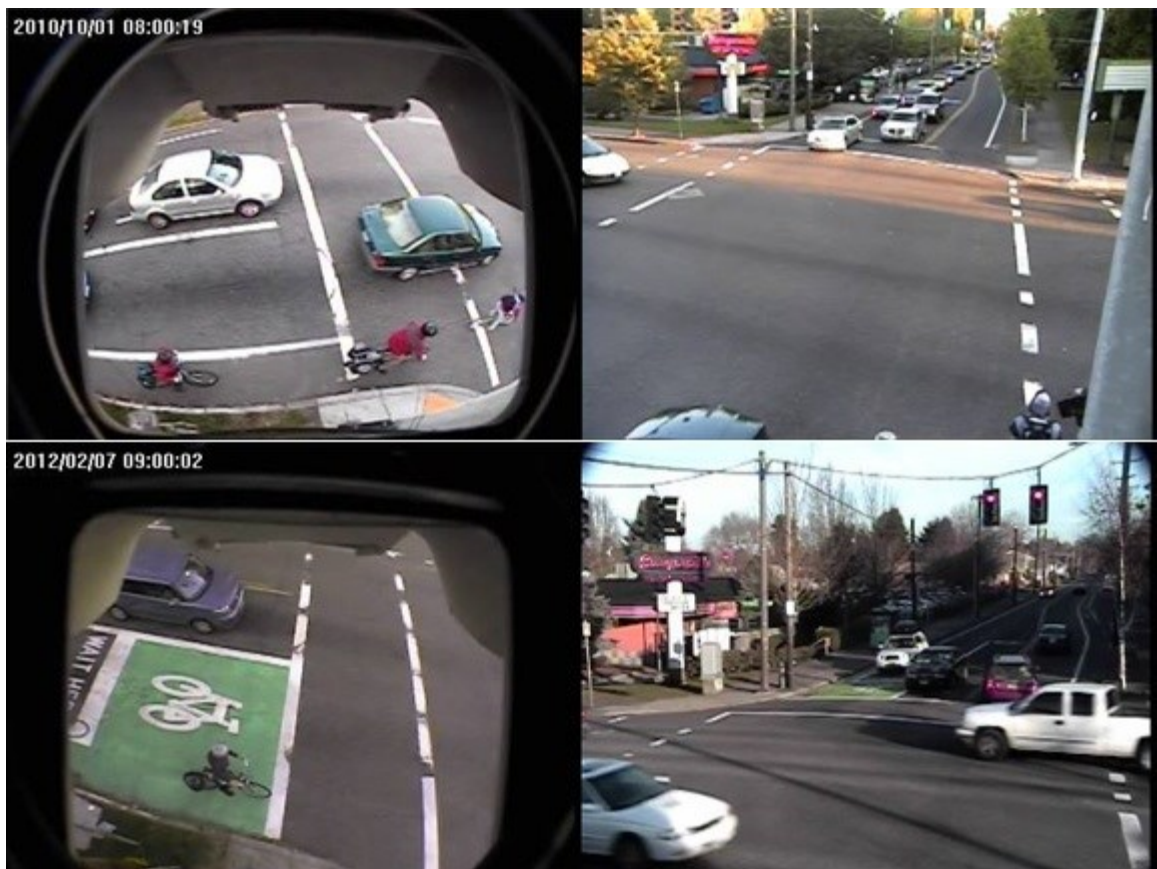
The intersection of SE 26<sup>th</sup> Avenue at Powell Boulevard (viewing northbound) was observed in the fall prior to the installation of the bike box and in the winter season afterwards. The bike box was installed on the both approaches of SE 26<sup>th</sup> Avenue; however this video only observed the bike box area on the northbound leg. The approach on SE 26<sup>th</sup> Avenue is a three-lane, two-way roadway with a dedicated left-turn lane at the intersection. Bike lanes are available along both sides of the street on both sides of the intersection. Figure 10 shows the available northbound camera views of the intersection for both study periods.

**Figure 10: SE 26th Ave NB at Powell Blvd Camera Views**

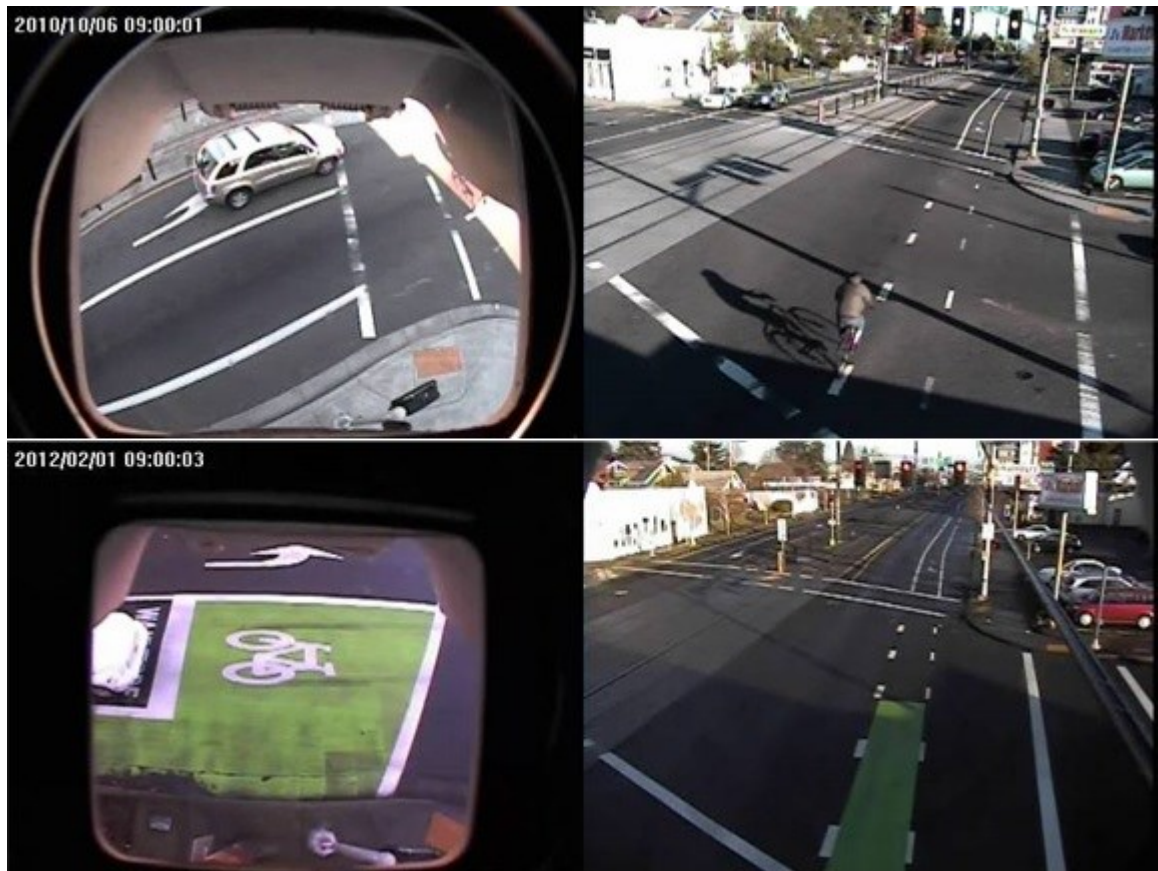
The intersection of N Interstate Avenue at Alberta Street was observed in the fall prior to the installation of the advanced stop box and in the winter afterwards. The bike box was installed on the northbound N Interstate approach. Interstate Avenue is a single lane, two-way roadway divided by light rail tracks. At the intersection, the roadway expands to include a dedicated left-turn lane. Bike lanes are available on both sides of the street before and after the intersection and on-street parking areas are provided after the intersection. Figure 14 shows the camera views at the intersection observed for both periods of study.

**Figure 14: N Interstate Ave at Alberta St Camera Views**

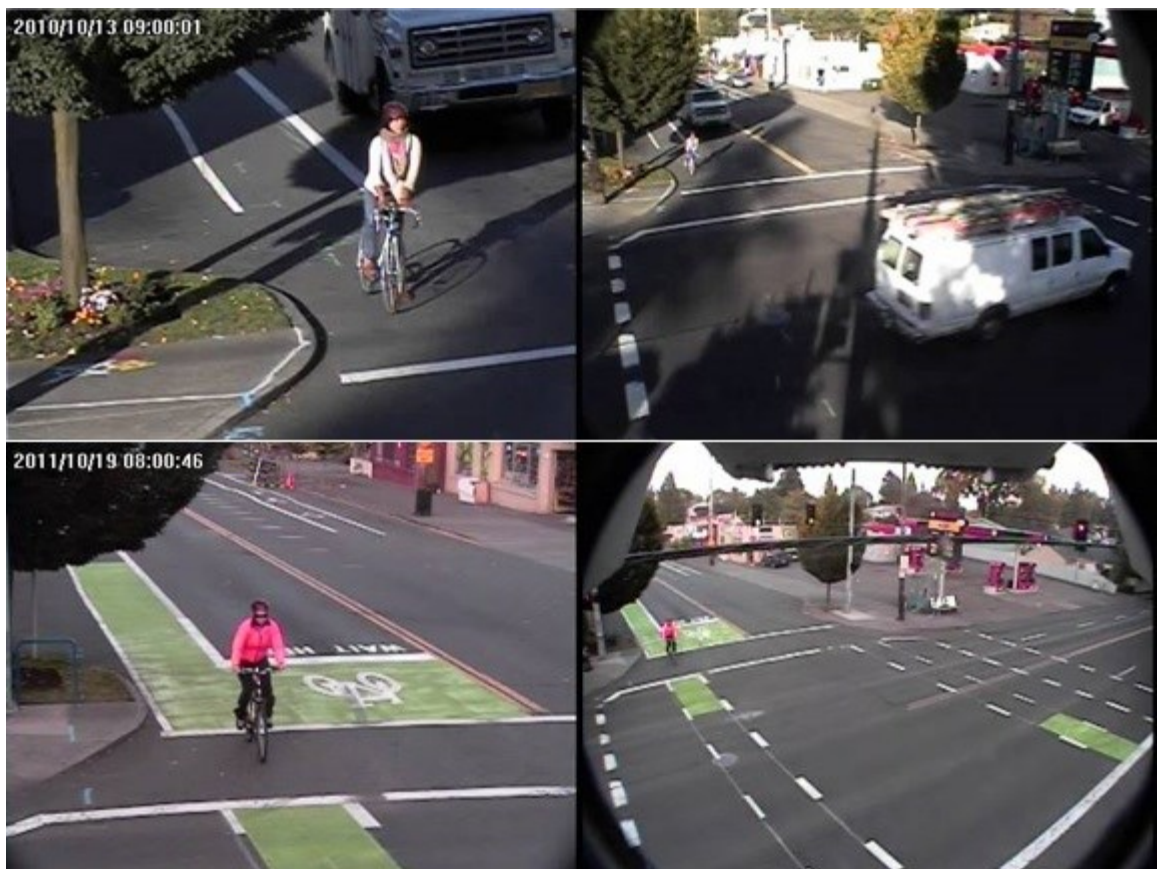
The intersection of SE Gladstone Street at Cesar E Chavez Boulevard (viewing eastbound) was observed in the fall prior to and after the installation of the advanced stop box. The bike box was installed on both of the approaches from SE Gladstone Street; however, this video only observed the bike box installed on the eastbound leg. The approach on SE Gladstone is a two-lane, two-way roadway with a single lane used for all turning movements. Bike lanes and on-street parking areas are available on both sides of the roadway on each side of the intersection. Figure 16 shows the available eastbound camera views at the intersection observed for both periods of study.

**Figure 16: SE Gladstone St EB at Cesar E Chavez Blvd Camera Views**

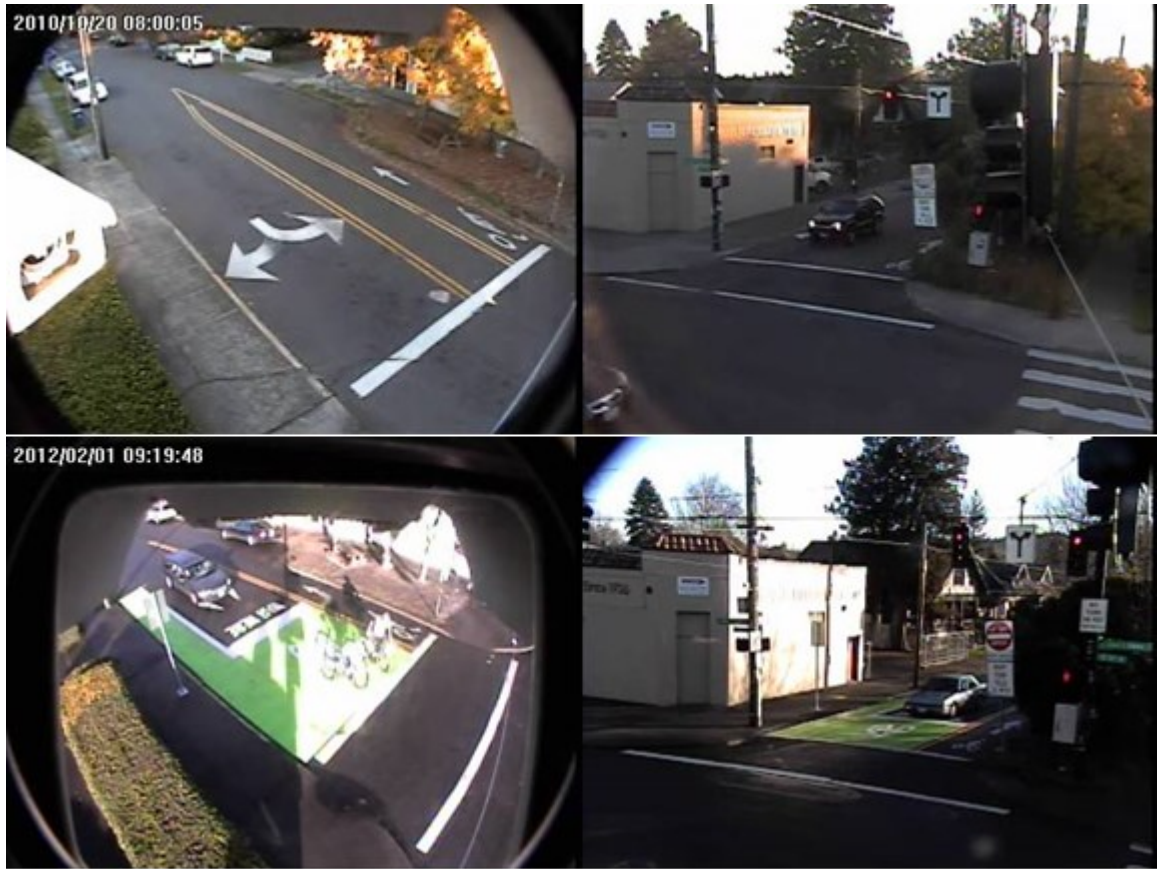
SE Lincoln Street is considered a Neighborhood Greenway by the City of Portland in which bicyclists are permitted to take the lane; therefore, bike lanes are not provided prior to or after the intersection. On-street parking areas are available on both sides of the roadway on each side of the intersection. Figure 19 shows the available eastbound camera views at the intersection observed for both periods of study.

**Figure 19: SE Lincoln St EB at Cesar E Chavez Blvd Camera Views**

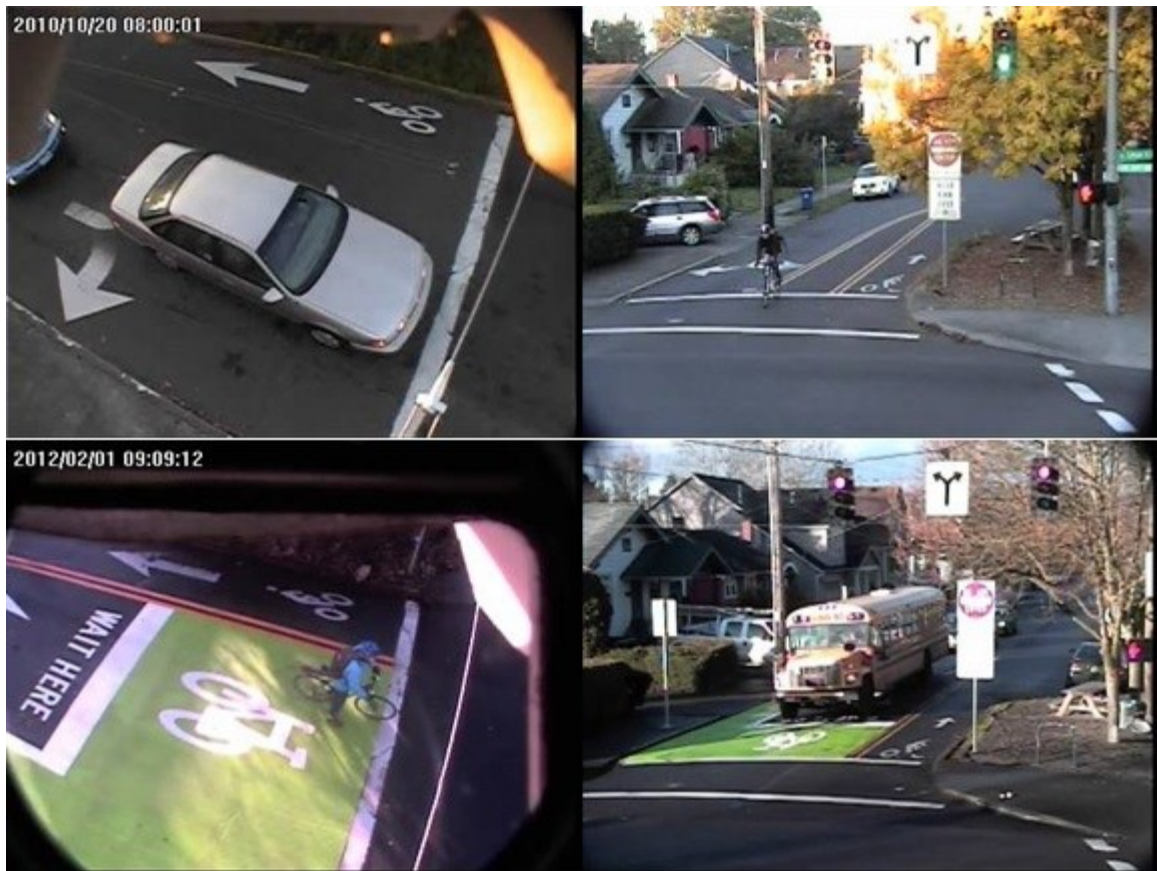
similar in design. Like before, the approach on SE Lincoln Street is a two-way roadway, but motorized vehicles are not permitted to travel through the intersection or turn from Cesar E Chavez Boulevard. Bike lanes are not provided beyond the areas for the advanced stop box. On-street parking areas are available along both sides of the street on each side of the intersection. Figure 21 shows the available northbound camera views of the intersection for both study periods.

**Figure 21: SE Lincoln St WB at Cesar E Chavez Blvd Camera Views**

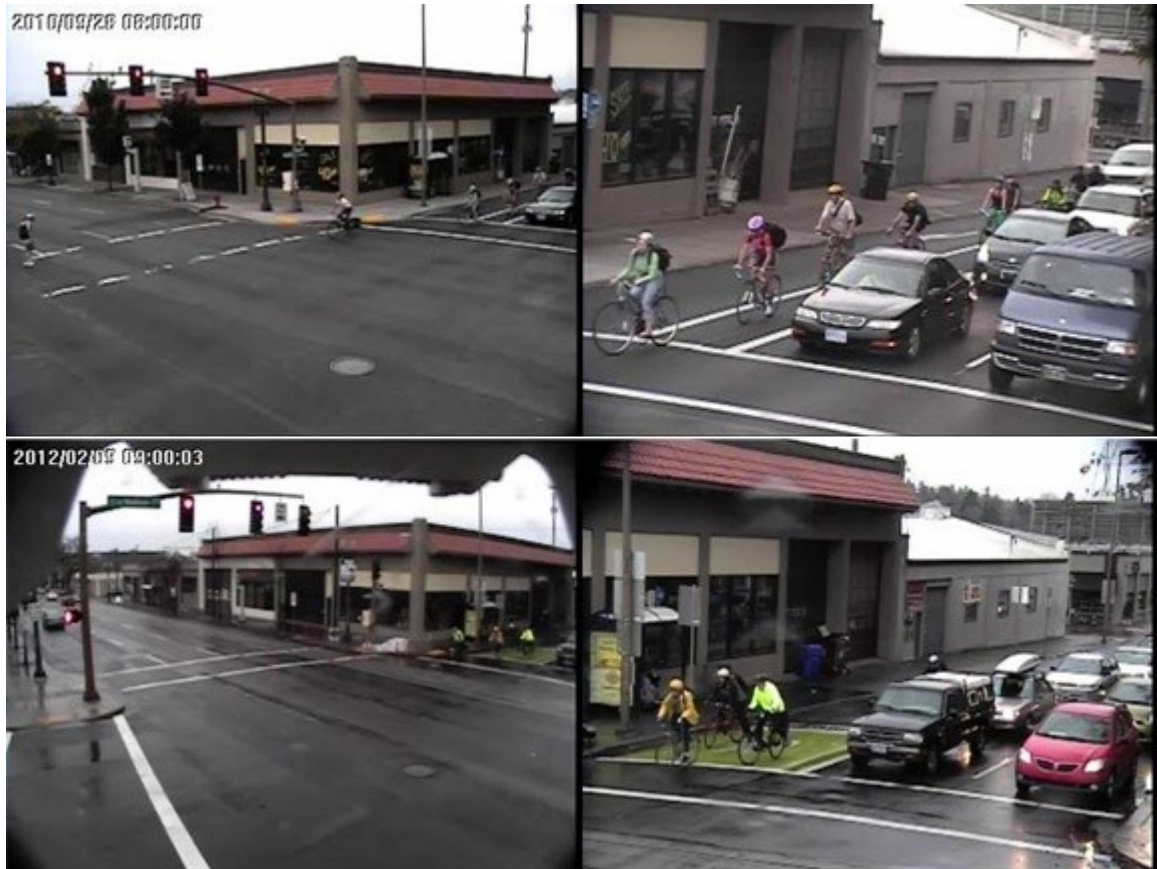
The intersection of SE Madison Street at Grand Avenue was observed in the fall prior to the installation of the advanced stop box and in the winter afterwards. The bike box was installed on the westbound approach of SE Madison Street in the far right lane (within the right-turn refuge). Madison Street is a three-lane, one-way roadway with two through lanes and one dedicated right-turn lane. Bike lanes are provided before and after the intersection. On-street parking areas are available along the right side of the roadway (which is designated as a bus only lane for travel) for a short span at the start of the block, but once the right-turn refuge develops parking becomes restricted. However, a bus stop is present within the right-turn refuge from which buses can instead travel through the intersection. Figure 23 shows the available camera views of the intersection for both study periods.

**Figure 23: SE Madison St at Grand Ave Camera Views**
